## Attempt to Evaluate a Structure Sensor's Accuracy in Recording the Status of Venous Ulcers of the Lower Extremities

This article attempts to assess the accuracy of a Structure Sensor — a low-precision 3D scanning device — to monitor the progression of venous leg ulcers. The study was conducted on 11 volunteers. Preliminary results indicate that this technology can be used as an effective tool in the ulcer diagnosis. Because the device is easy to use and its cost is low, it has the potential to enter everyday medical practice. Faster and simpler ways to perform diagnostics can help improve patients' quality of life and optimize treatment processes. This study opens up new perspectives on the use of low-precision 3D scanners in some areas of medicine.

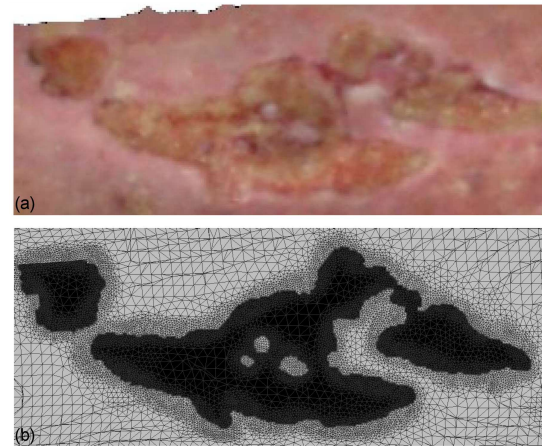
Fig. 1. Exemplary scanned image (a) texture before processing) and after processing overlaid on a locally dense triangle mesh (b).

The data that the device provides after scanning includes two independent files. The first contains the texture, represented by an image encoded in jpg format, while the second contains the triangle mesh information in obj format. When the data in this form is loaded in a graphics program, the texture is mapped to triangles to form a color 3D image. This form of data representation simplified further work, because it was possible to proceed to data analysis without converting the data or creating dedicated software. Since no software could automatically determine the area of ulceration based on the aforementioned data, it was processed using two free, open-source programs, namely GIMP [8] and Blender [9]. The algorithm of the procedure is as follows. First, an area of ulceration was pre-selected in GIMP using the Magic Wand tool. The resulting mask was modified manually to cover only the mentioned region. The selected area was painted black, and everything outside it was white. As a result of these actions, a time-and-white image was obtained, which became a new texture for the recorded data. The 3D data with the new texture was loaded into Blender, where the mesh was edited by thickening it within the ulceration. This made it possible to simplify the process of analyzing the data, as only whole triangles of the mesh, whose vertices (vertex) were assigned the color black, was taken for surface calculations, rather than parts of the triangles calculated based on the distribution of the texture on their surface. An example image of the texture and locally thickened mesh for one of the analyzed ulcers is shown in Fig. 1a and b. In addition, classic photographic documentation was performed using the Fotomedicus system (ELFO®, Poland).

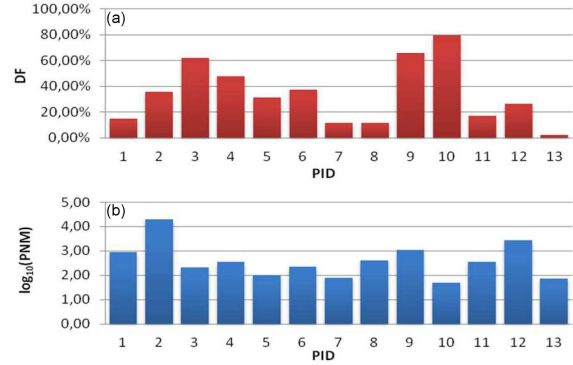
Fig. 2. Relative percentage difference between 3D scanner and planimetry measurements — DF (a), decimal logarithm of ulcer area calculated based on planimetry —  $\log_{10}(\text{PNM})$  (b), PID is a patient sequence number.

The relative percentage difference was compared with the decimal logarithm counted for the area determined using planimetry expressed in mm<sup>2</sup> to see if the size of the area affects the difference (Fig. 2).

Analyzing the image in Fig. 2, it was noted that the application performs better with small ulcers, where there is no need to move the sensor around. This is probably due to the fact that the errors caused by the algorithm for merging compound texture images into a single entity are small here for this reason. Image merging algorithms don't do very well with images without many feature points to rely on in the calculations. Unfortunately, a small area also means a small area in the image that is a texture for the data and a high chance of marking points that do not belong to the ulceration, which can be a source of error.
